19<sup>th</sup> INTERNATIONAL CONGRESS ON ACOUSTICS  
MADRID, 2-7 SEPTEMBER 2007

## Acoustical Design of New Concert Hall in Mariinsky Theatre, St. Petersburg

Mid-size concert hall with 1,100 seats opened in St. Petersburg, Russia on November 29, 2006, as an extension of the Mariinsky Theatre. The new hall's configuration basically has a shoebox shape, but many seats are arranged around the stage and the slope of the main seating area is quite steep. The design direction was something like an amphitheatre in a shoebox shape. Acoustical design and characteristics of the hall are reported.

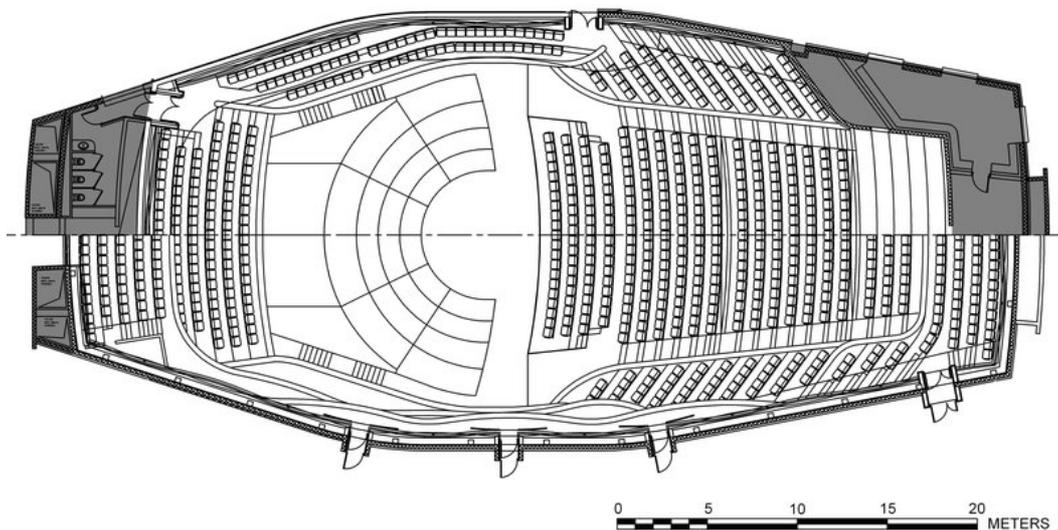
Figure 1.-Plan

The new concert hall's dimensions measure 22 m wide, 52 m long and 14.5 m from the stage floor to the ceiling. The total room air volume is approximately 12,000 cubic meters for 1,100 seats. Longitudinal and cross sections and plan of the hall are shown in Figures 1, 2 and 3, and perspective view in longitudinal section is shown in Figure 4. While the hall's configuration basically has a shoebox shape, many seats are arranged around the stage area and the slope of the first floor's main seating area is quite steep, two room design elements that distinguish this hall's configuration from the configurations of halls known throughout the world as the exemplars of the shoebox shape. The steep slope of the hall's first floor main seating area enables a large portion of the audience to view the entire stage. The sloped floor also creates a feeling of oneness between stage and audience areas and contributes to the sense of presence experienced in the hall.

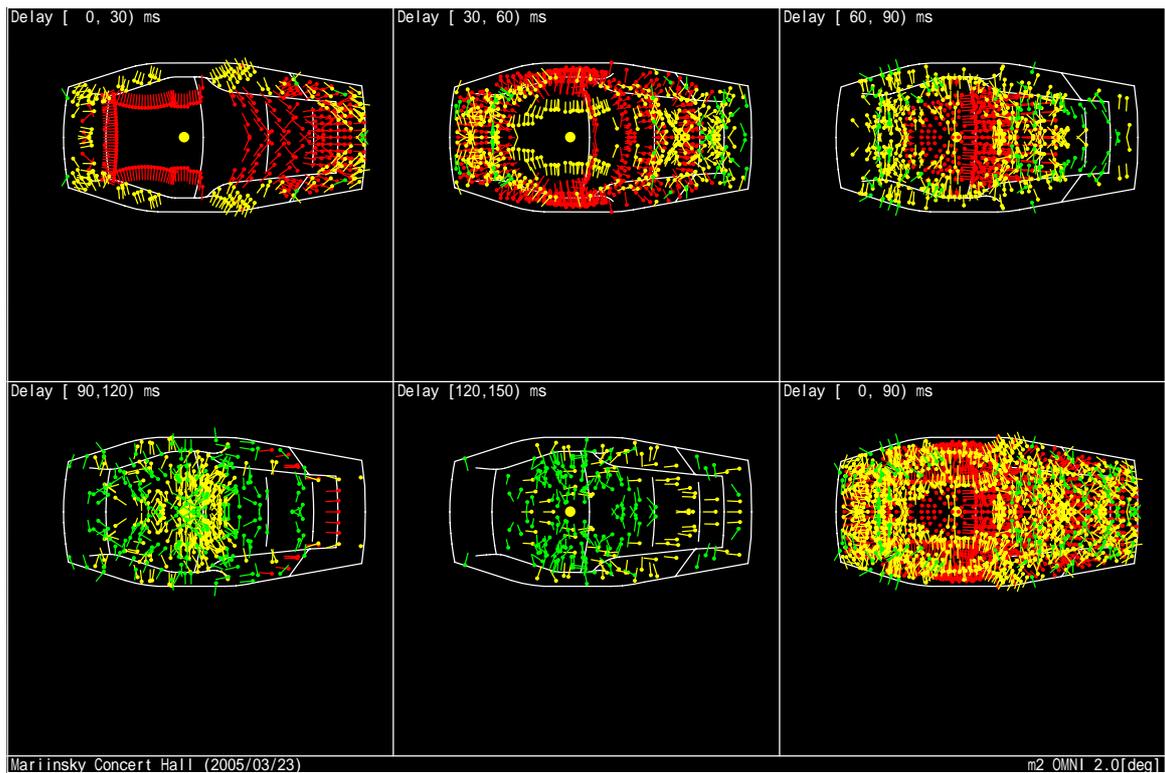
Room shape and dimensions were studied with the computer simulation in terms of distribution of early reflections for different time periods (0-30ms, 30-60ms, 60-90ms,.....). Figure 5 shows the distribution of the early reflections in the hall.

Figure 5.-Distribution of early reflection (Computer simulation study)

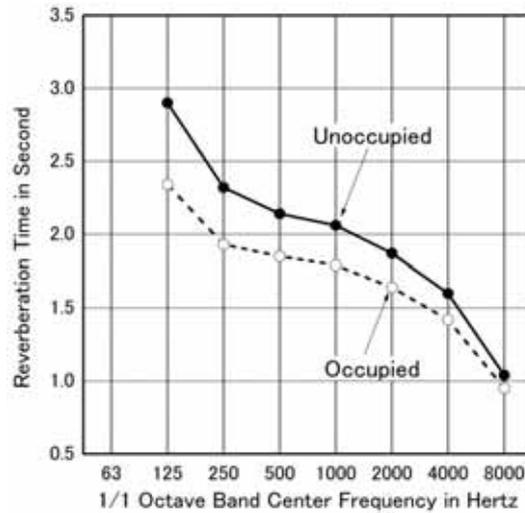
The reverberation times (RT60) measured when completed are shown in Figure 6. RT60 at 500Hz is approx. 2.2 sec. (Unoccupied) and 1.9 sec. (occupied). (The data in occupied was estimated from the data measured in the empty hall.)

Figure 6.-Reverberation time (RT60)

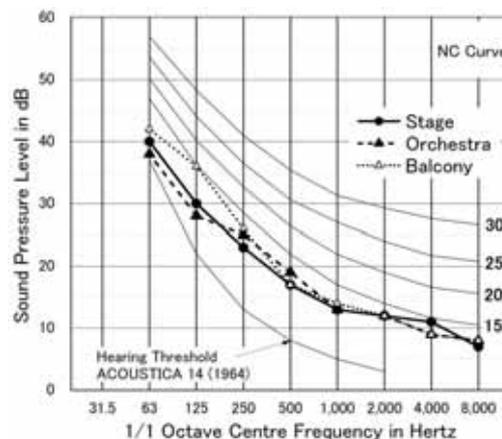
HVAC noise was measured in the hall. The results are shown in Figure 7. The noise level over the entire auditorium is below than NC-15.

Figure 7.-Noise level (NC) from HVAC
