ACOUSTIC PROPERTIES OF AN OLD STONE ATRIUM USED FOR CONCERTS

ABSTRACT

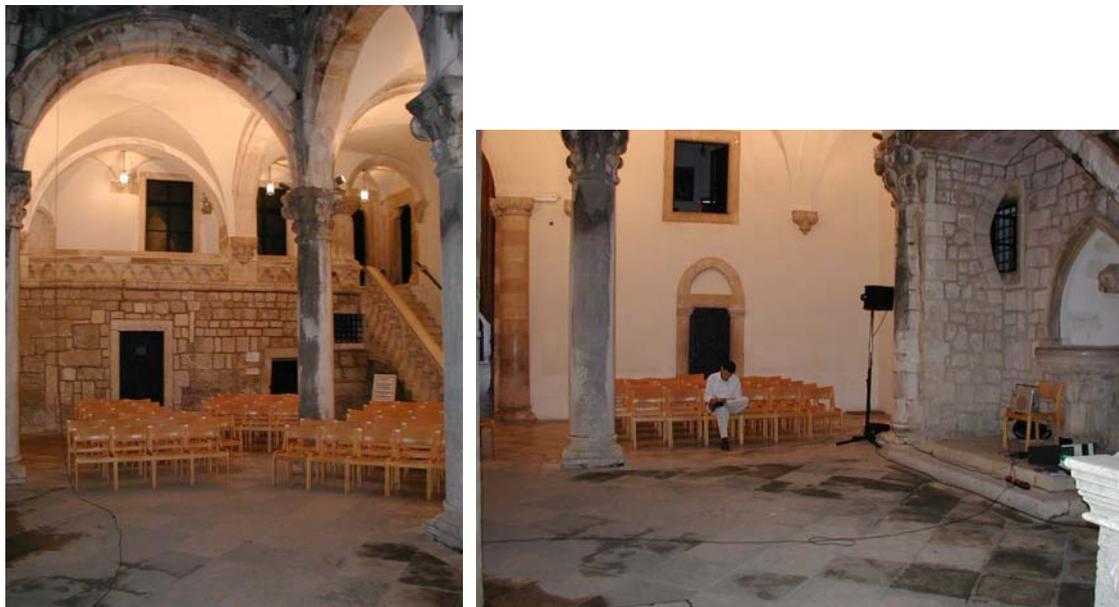
Fig. 2. Left - back view of the atrium (with public chairs) with the gallery on first floor. Right - left side of the ground floor, at left there is the main entrance.

The plan of the atrium is shown in fig. 1. The whole palace is built of stone and hard lime plaster. Only exceptions are some wooden doors. The floor of the atrium is made of glazed stone blocks. There are stairs leading to the galleries on the first (fig. 2 left) and the second floor (fig. 3), which is at double height of the first floor. The structure of the atrium is very complex, with numerous vignettes such as columns of different dimensions, column capitols, stuccos, etc. This complex structure contributes to the diffuseness of sound. Vertical walls are mostly smoothly plastered while some parts are made of stone. During the music events, simple wooden seats are placed in the atrium and on the galleries. There are usually less seats than visitors, so there are a lot of standing people on the stairs and galleries. There is no ceiling in the atrium (except the sky), which influences the acoustic a lot as well as the overall impression of the atrium, mostly because of the variable lightening.

The main music events held inside the atrium are soloist (piano up to quartet) and orchestra concerts (even symphonic orchestra). In the case of soloist concerts, musicians are placed near to the main staircase in front of the fountain (fig. 2), sometimes beneath the base of the fountain (guitar concerts) as well as beneath the angel statue at the entrance of the "Knezev dvor". When the orchestra becomes larger, the musicians are placed on the centre of the floor. An interesting change of sound impression happens when it begins to rain during a concert; all
