# ACOUSTIC RESONATORS IN SERBIAN ORTHODOX CHURCHES

## ABSTRACT

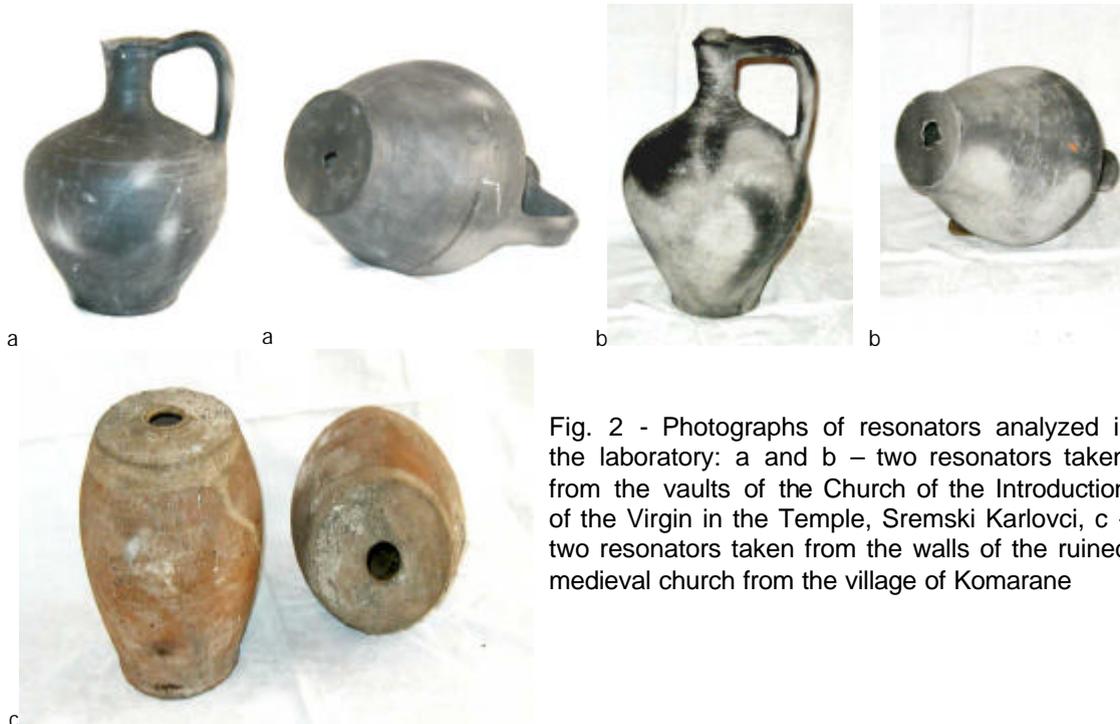
Some of the found ceramic vessels were taken from museum collections to the laboratory for the purpose of measuring their basic acoustic characteristics. Figure 2 shows photographs of some of the vessels taken at the laboratory. Figure 2a and 2b show two resonators taken from the vaults of the Church of the Introduction of the Virgin in the Temple at Sremski Karlovci (built in the 17<sup>th</sup> century). It is obvious that they are actually water containers turned into resonators by piercing holes in their bottoms. Figure 2c shows a photograph of two resonators taken from the ruins of an old church in the village of Komarane (dating unknown).

Fig. 2 - Photographs of resonators analyzed in the laboratory: a and b – two resonators taken from the vaults of the Church of the Introduction of the Virgin in the Temple, Sremski Karlovci, c – two resonators taken from the walls of the ruined medieval church from the village of Komarane

1. Resonant frequencies of all tested resonators are lower or equal to 131 Hz. Vessels from the Church of the Introduction of the Virgin in the Temple, with form shown at Fig. 2.a and 2.c, have very low resonant frequencies, between 72 and 102 Hz, while another two vessels, shown at Fig. 2.c, have it lower or equal to 131 Hz.
2. Bandwidths of resonant process in all resonators are lower or equal to 4Hz (resolution of measurement was 0,5 Hz). The lowest measured value were 1,5 Hz. All vessels were empty during the measurement due to the fact that they were empty where found in place.
3. Intrinsic reverberation time is in the interval 0,44-0,99 s. Again, all vessels were empty during the measurement.

In conclusion, the building of ceramic vessels into church walls and domes of Serbian churches is the result of orally transmitted tradition, without any real knowledge of their function. There are assumptions that, apart from the acoustic, the demand for building in of resonators also had a religious component. Finally, there are some observations that ceramic vessels, under the circumstances of an ambiguous acoustic function, were also used as constructional elements, something like a forerunner of present-day hollow bricks. As such they were also used in buildings other than churches. There is a note that the dome of the Bayrakli mosque in Belgrade consists of a large number of built-in ceramic vessels, like those from fig. 2, supposedly for reasons of static, due to the small overall weight of such a construction [4].

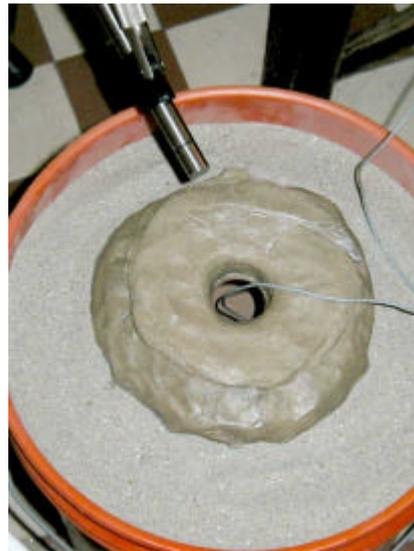
Acoustic analysis of a resonator implies the measurement of parameters relevant to describe the resonant process in it. That involves: resonant frequency, bandwidth and intrinsic reverberation time (or decay constant of resonant process). For that purpose an appropriate setup were prepared in the laboratory, as shown at Fig. 3.

Fig. 3 - Laboratory setup for the measurement of acoustical parameters of the ceramic vessel if used as the resonator.

The large plastic container was used for ceramic vessel placement in all measurements. Inside the container the tested vessel is embedded in sand to achieve the environment as it was originally in church wall. It was estimated that ceramic walls of vessel are too transparent at frequencies as low as can be expected for its resonant frequencies. At resonators equivalent circuit such transparency can be modeled by a wall impedance parallel to the acoustic capacity. When the vessel is removed from the wall and stands freely in the air, influence of low wall impedance value causes some changes in decay constant, and according to that, in resonator's intrinsic reverberation time. To prevent this effect ceramic vessel is embedded in sand during all measurements. Some preliminary tests in the laboratory revealed changes in reverberation time values up to 20% when the ceramic vessel is removed from sand.

Round shaped piece of putty about 2 cm thick is applied around the resonator's hole, as shown at figure 3. During the measurements it simulates mortar originally present over resonators when built in church walls and vaults. The thickness of 2 cm is estimated as the least possible mortar layer thickness when applied on church walls. The thickness of vessel wall around the hole is 45 mm. So, 2cm of plaster should have strong influence on resonant frequency value. Testing of possible mortar influence upon resonator performance was also carried out, Some results obtained are presented at fig 4. Significant lowering of resonant frequencies with mortar around resonators aperture is obvious.

Two microphones were used for the measurement. The first, a standard laboratory microphone, is placed outside the resonator, in the vicinity of its aperture. The second microphone is placed inside the vessel through its aperture. For this purpose a special, very small microphone is used, taken from a hearing aid. This microphone is connected to the measurement system by a very thin cable in order to minimize its influence on the size of the aperture area, as visible at Fig. 3.
