## **NOISE FROM URBAN TRANSPORT, NOISE EMISSION OF TRAMS**

### **ABSTRACT**

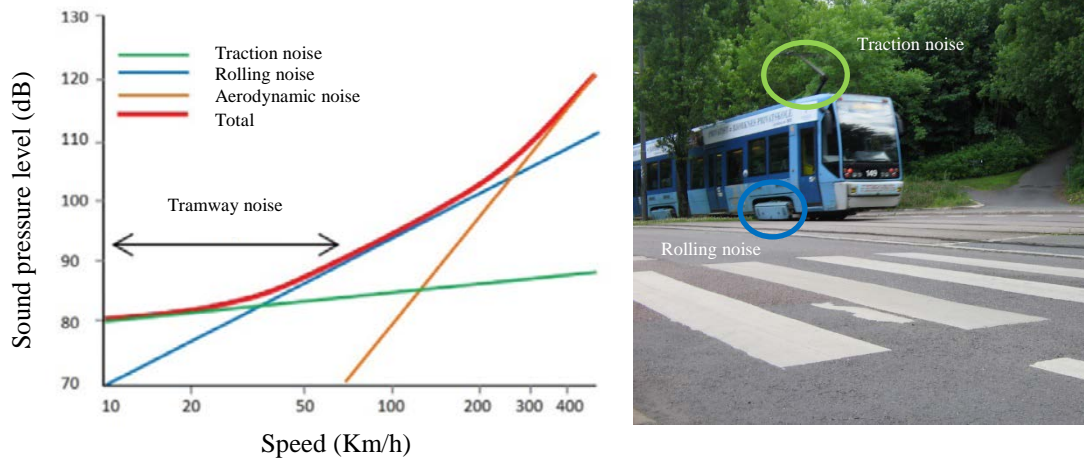
Figure 1 Sound pressure level for typical noise sources at different speed range [1]

The rolling noise is originated from the contact point between the rail and wheel of the train and depends on the roughness of them both. The traction noise is mainly dependent on the type of train. In general, noise sources are somewhat influenced by the train speed. The transition from traction noise to rolling noise and from rolling noise to aerodynamic noise as a function of train speed is shown in Figure 1. The absolute and relative noise levels shown in Figure 1 are only indicative and will vary with the type of train.

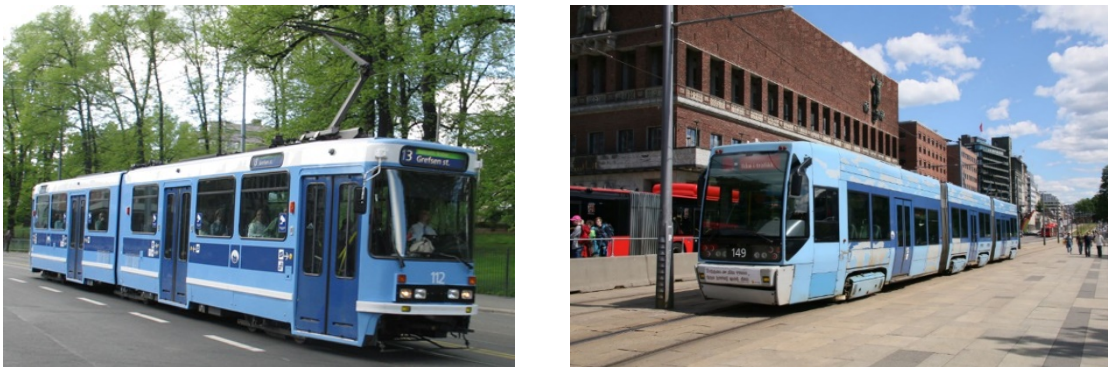
Figure 2 Trams and metro in Oslo. Tram type SL-79 (left), tram type SL-95 (right)

In Norway, tramways operate in Oslo, Trondheim and Bergen. This article builds on measurements of noise and vibrations from trams and metros of Oslo. The two models of trams that operate in Oslo are: SL-95 and SL-79, see Figure 2.

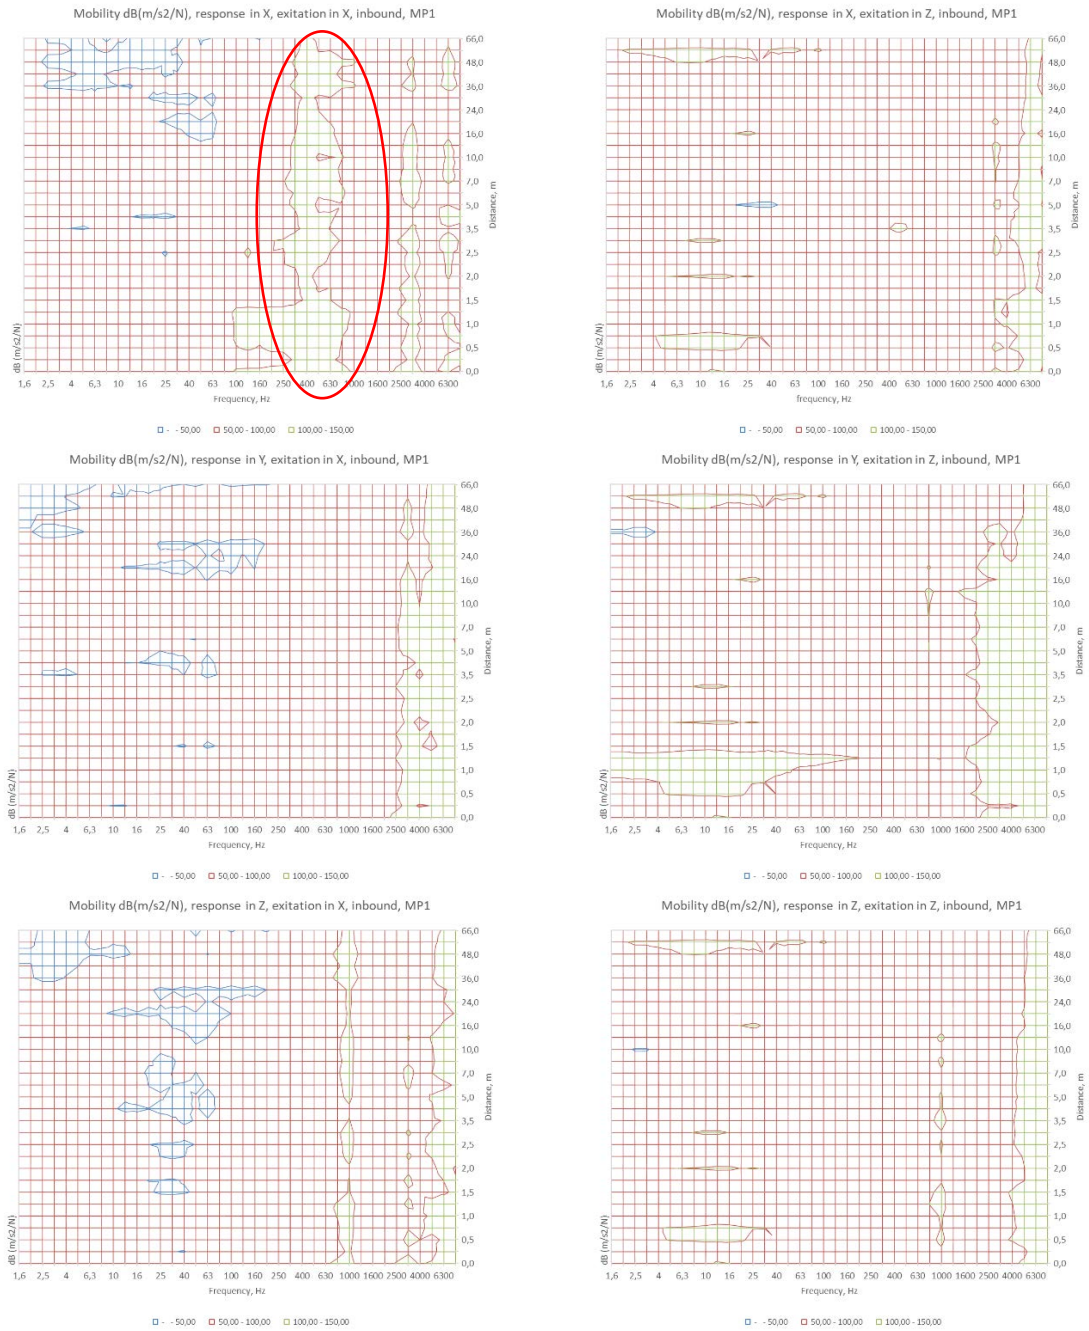
Figure 9 Mobility of the train track vs distance and frequencies. Horizontal impulse force (left), vertical impulse force (right)

Analysis of track decay measurements is shown in Figure 10. This figure shows the mobility response of the track for all frequencies (horizontal axis) vs. distances (vertical axis). The track vibrates easily at frequencies between 400-600 Hz, when the track is excited in transverse directions. Track decay analysis was performed for both measurement points of tram and metro. The same results were found.
