The Use Of Acoustic Cameras In Assisting The Testing Of Baffle-type Acoustic Windows And Balconies

ABSTRACT

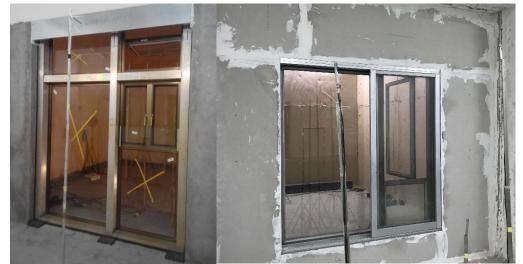
Figure 1 Test windows installed with brick Walls (left) and carcass made of gypsum boards with infills (right)

Using bricks and cement sand construction is the most traditional way to install any windows and balconies. A properly built brick walls of 100mm could achieve STC 45. It is the cheapest and easiest way to build. With the procedure of grouting with the cement sand rendering, it is the most reliable way to seal all gaps between the specimen and the adjoining wall. However, this method takes very long time to let dry and it is time consuming to demolish and reconstruct with another test specimen. Alternatively, layers of solid timber board and gypsum board with acoustic insulation infill can also be used to construct the carcass for installing the test window or specimen in the acoustic chambers. Timber and gypsum board are indoor material that can only be used at indoor. Sound insulation materials like fibreglass or rockwool are used to increase the transmission loss of the carcass. The testing specimen is then fixed in-situ and grouted with silicon sealant which is a typical final fixing as in installing the window installed at a 200mm thick brick wall and a plenum window installed on a 200mm thick wall constructed with 150mm bricks and gypsum boards on both faces.

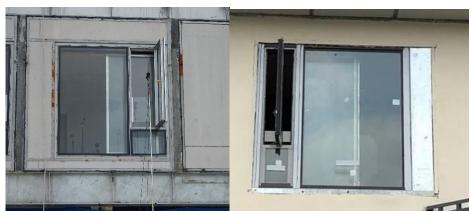
Window installation and test room construction is the most time-consuming process in each cycle. To speed up the installation, using dry walls and dry-fixed method is the newest trend. Concrete sandwich panels or metal sandwich panels with metal frame tailored to size are used. Figure 2 shows two windows installed using this method. The construction can be done down on the floor and hoisted up into position for installation. The panels used are of higher STC than the testing specimen. The interfacing of the window frame with the installation are also sealed with silicon sealant to ensure it is gap free.

Figure 2 Test windows installed at testing facades with concrete sandwich panel (left) and metal sandwich panel (right)
