## **Noise and vibration evaluation of the Budapest metro train's monoblock and duoblock wheels**

### **ABSTRACT**

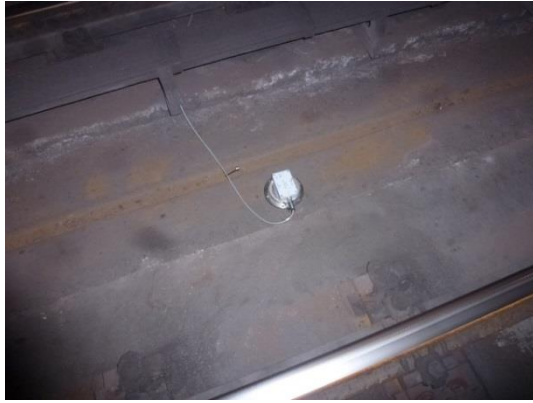
Parallely, two acceleration meter were placed in the tunnel: one three-directional in the axis of the track on the track plate and 1 one-directional on the tunnel wall.

Picture 3-4: Vibration measurement in the tunnel

In the residential building and in tunnel at the same time fulfilled measurements, in order to identify the subway cars passed by the time of the meters were harmonised.

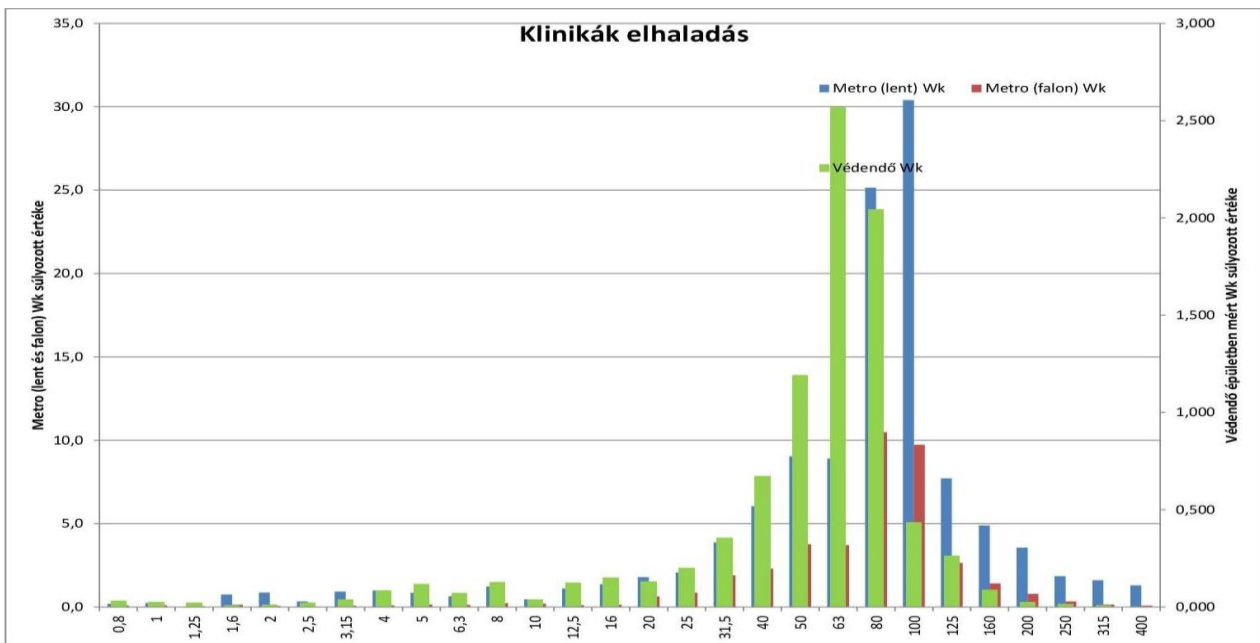
During the measurements, frequency analysis was performed in 1/3 octave band. The frequency spectrum of the measured vibration at the different measurement points on the left and right tracks is illustrated in the following figure:

Figure 5.: 1/3 octave band spectrum (0.8-400 Hz) of an average metro rake passage at Station Klinikák

Based on the previous figure, it can be stated that the vibration load from the metro passage propagates significantly in the 63 to 80 Hz spectrum from the tunnel to the buildings.
