## PERFORMANCE OF BUILDING BASE ISOLATION: THE TWO-LEVEL APPROACH

*Iñigo Arana Goenaga<sup>1\*</sup>*  
*Albert Isnardo Iglesias<sup>2</sup>*  
*Amadeu Segura Torres<sup>2</sup>*  
*Pere Vicenç Rodríguez Sorribes<sup>2</sup>*  
*Hamid Masoumi<sup>3</sup>*  
*Amina Aïssani<sup>3</sup>*

<sup>1</sup>CDM Stravitec, Barcelona, España

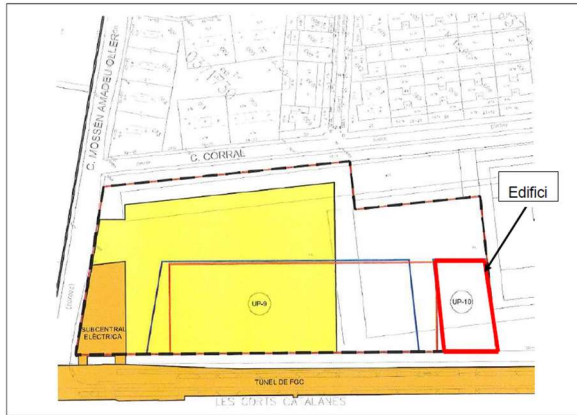
**Figure 1.** Location of the building and its distance from the railways.

close to the building, could generate important levels of noise and vibrations in his building. Figure 1 shows the location of the building and its distance from the FGC railway tunnel.

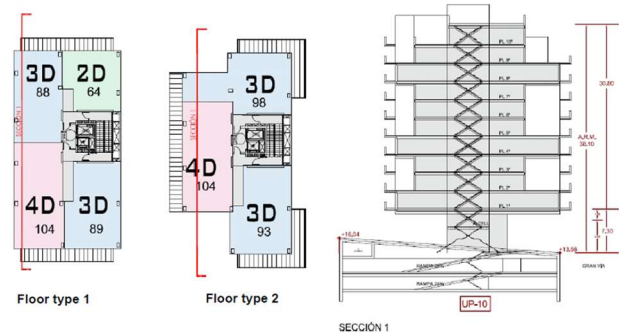
**Figure 2.** Cross section of the Building and Floor types.

Figure 2 below provides a cross section of the building at the height of the tower and a cross section of the different floor types.

The residential tower building, used as a case study in this paper, consists of a multi-storey residential building (Figure 2). It is located in GRAN VIA Street, in Barcelona close to tunnel Lines L8, R5 and R6, among others of the railways of

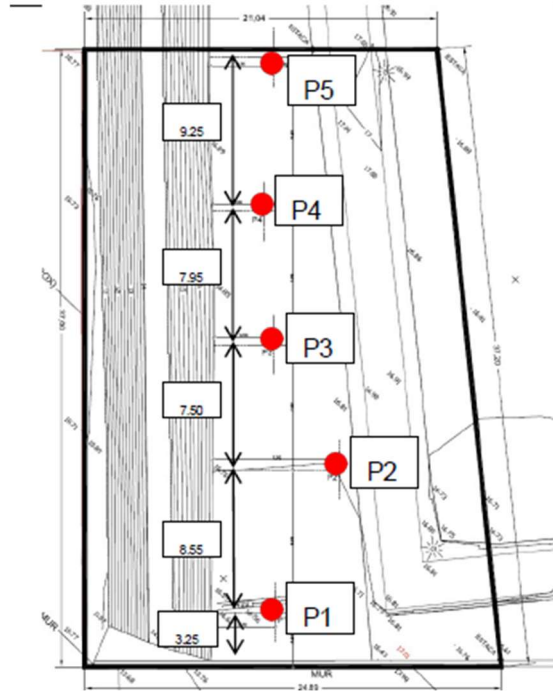
**Figure 3:** Location of vibration measurement points

Figure 3 shows the location of the different measurement points vis à vis the railway. Five points were located along the surface area occupied by the building, to control the vibration reduction. These five points were considered enough to cover all the analyzed area, locating the P1 the closest to the tunnel, considering it the worst case.

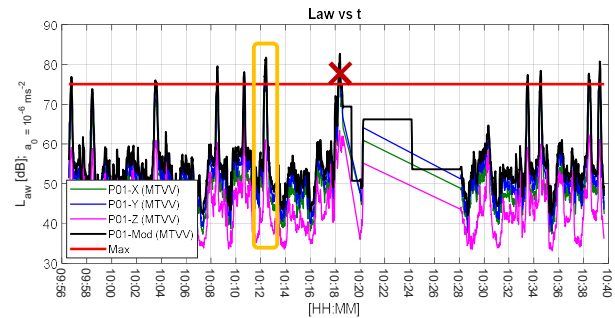
As an example, Figure 5. Shows the time evolution of  $L_{aw}$  in the P1 location (the worst case). Where we can clearly identify that the maximum  $L_{aw}$  level due to the passing train at point P1 is 81.8 dB, identified with a yellow mark.

**Figure 5.** Measurements at P1. Note: between 10:20 and 10:30, the hollow refers to an event not related to the train passage – here a crane movement onsite.

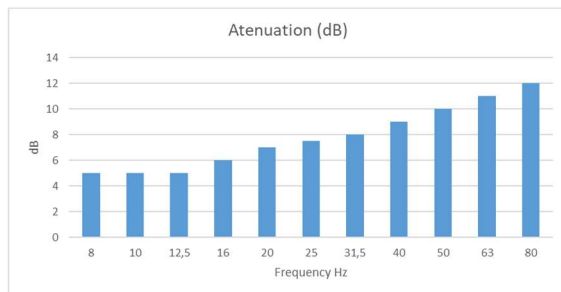
**Figure 6.** Attenuation due to the soil/building coupling.

The Figure 6 below, shows the attention applied for each frequency band according to FTA [2].

After applying the attenuation for each of the frequency bands and for the typical spectrum obtained at each measurement point, the estimated levels of  $L_{aw}$  are indicated in the 3<sup>rd</sup> column of Table 3.

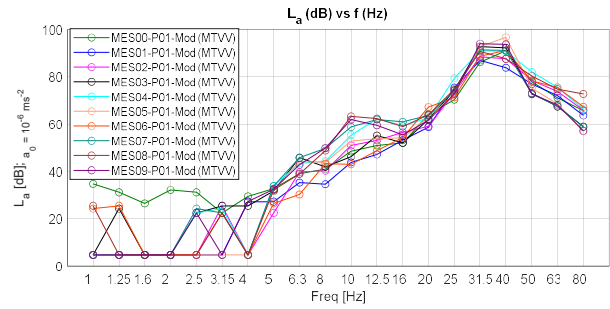
**Figure 7.** MTVV spectrum (XYZ) at the time of maximum level of train passing by.

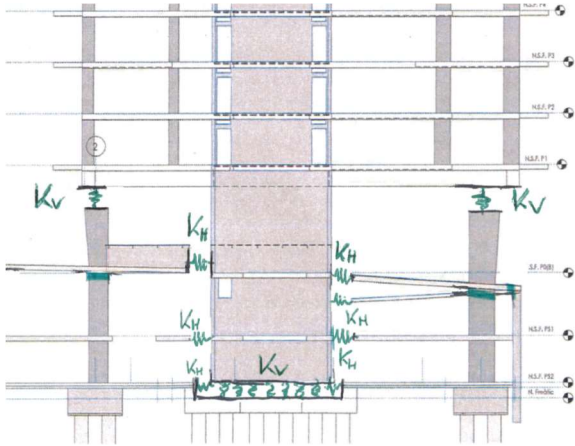
**Figure 8.** Isolation strategy.

**Figure 8** shows where the isolation will be integrated, specifically :

1. Adding isolators on top of pillars below the 1<sup>st</sup> floor.
2. Adding isolators vertically and horizontally at the core walls in the basement (level -2). See Figure 9.
3. At slab level: cut the slabs and Insert corbels to support the slab. The corbels will then be decoupled from the slab using an isolator. See Figure 10.

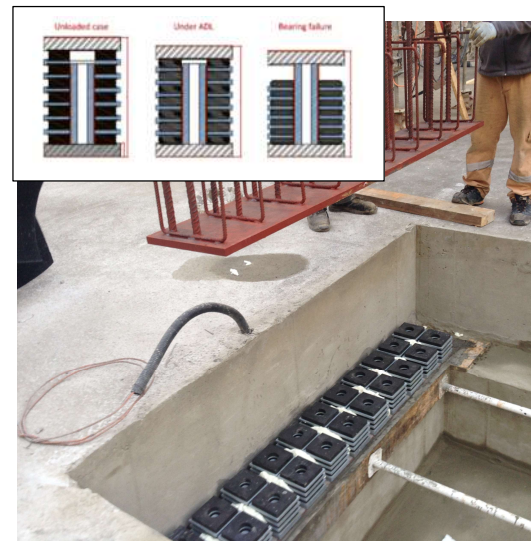
**Figure 11.** Installation of the VHS (very high stress) bearings with integrated failsafes.

In this regards, after numerous discussion with the design team, the manufacturer of vibration isolation has recommended the use of bearings with integrated failsafes, as shown in Figure 11. The steel failsafe does not engage unless that bearing stability is compromised.

Based on the level of the vertical loads and the limited footprint area, the Very High Stress - VHS sandwich bearings<sup>2</sup> have been proposed to isolate the core walls and the column heads. Moreover, the client has requested his design team to include failsafes (additional safety measures) in the event of major accidents (such as fires, explosions, etc).

<sup>2</sup> These VHS sandwich bearings refer to **Very High Stress** bearings and consist of an alternance of steel plates and elastomeric sheets which allow to sustain higher loads than traditional elastomeric bearings, in a limited footprint area.

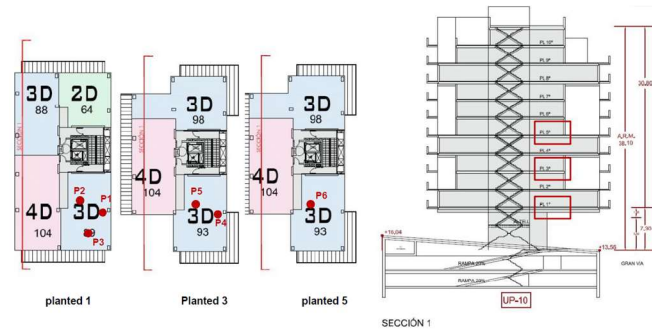
**Figure 12.** Location of the vibration measurement points in the building.

Following the completion of the project, the acoustic consultant went back to the construction site to evaluate the performance of the vibration isolation. A measurement campaign has been carried out and different measurement points have been selected in the building in the floors 1, 3 and 5 respectively. (Figure 12)

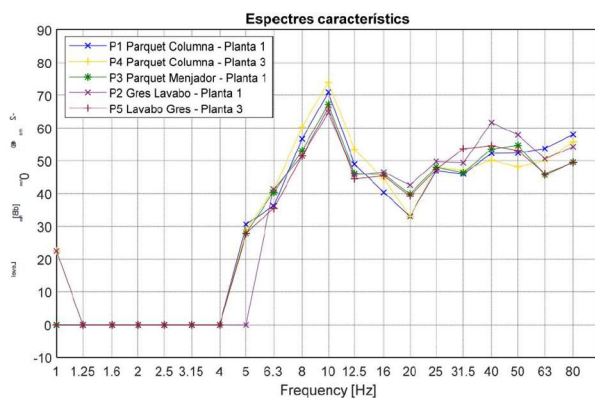
Figure 13. below shows the time evolution of the vibration levels at the different measurement points. The vibration spectrum of the maximum peak detected at all the measurement points of floor 1 and 3, is shown in the Figure 13 below.

In Figure 13, we can clearly notice how the vibration levels measured around this range have been reduced considerably; from 16Hz the levels oscillate between 50 and 60 dB.

**Note :** The peak at around 10 Hz reflects the isolation frequency of the isolation system.

**Figure 13.** Spectrum of the averaged vibration inside the building above of the vibration isolation system.

The measurements results show that the isolation was effective and achieved the expected performance. Table 4. below shows the measured  $L_{aw}$  in the different measurement locations. All measurements confirmed that the limits imposed by the regulation are respected.
